A12W0090-D2-L1

02 November 2012

Subject : AVIATION SAFETY INFORMATION A12W0090-D2-L1
Overtravel of Elevator Flight Control System in Pitts S-1S Aircraft

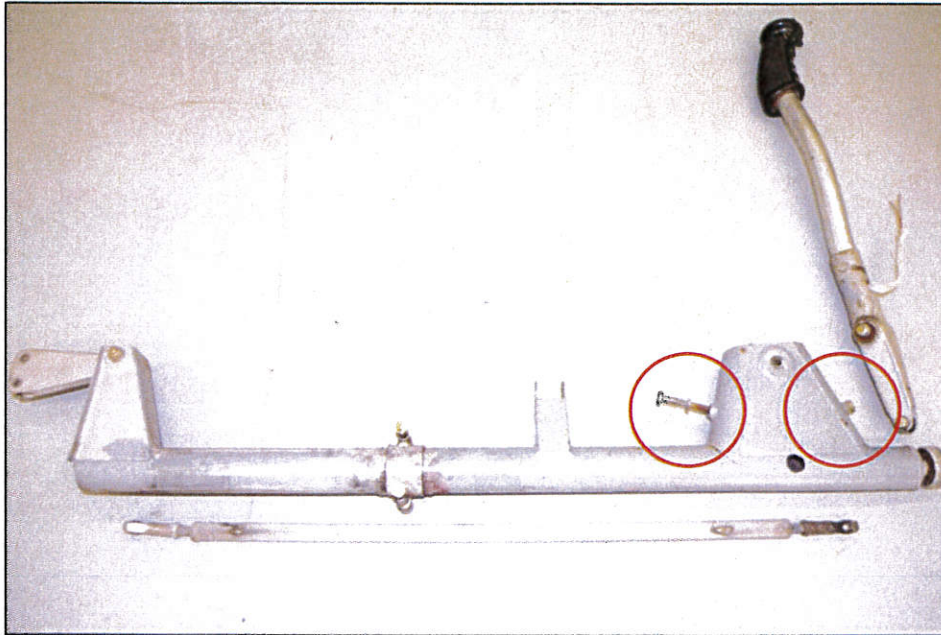
The elevator control system on a Pitts S-1S is a conventional push-rod system. Elevator travel limits are set by adjusting two elevator stop bolts that thread into nuts welded on the shroud on the elevator torque tube assembly, near the base of the flight control stick (See Photo 1).

Photo 1. Pitts S-1S elevator control stick, torque tube, elevator stop bolts and forward elevator push-rod

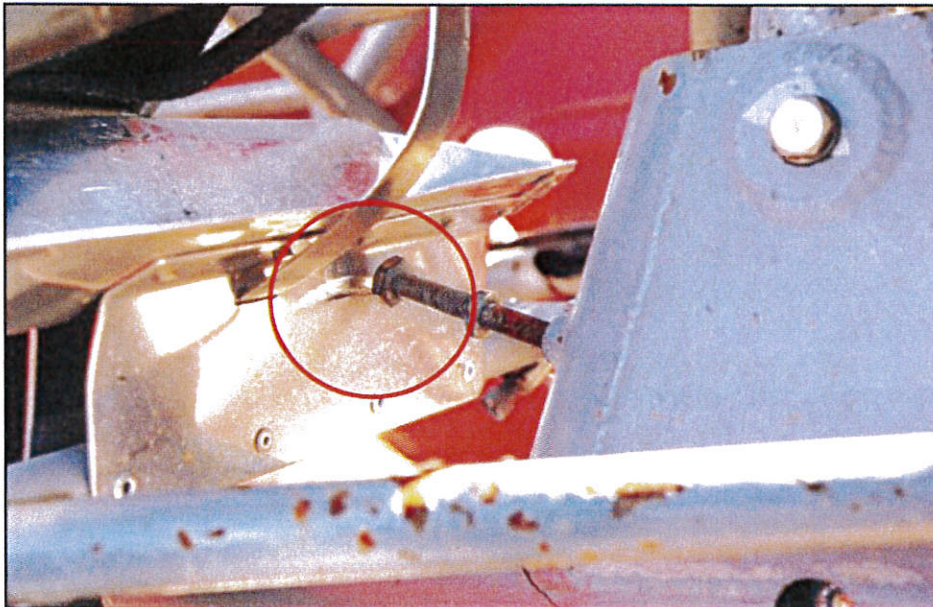
During wreckage examination it was identified that the down elevator stop bolt, which limited forward control stick and down elevator travel, had backed out about 11/16 inches. The lock nut was not securing the stop bolt and the head of the bolt had been rubbing on the forward face of the cockpit fire extinguisher bracket for some time (See Photo 2).

Photo 2. Elevator stop bolt contacting fire extinguisher bracket

The elevator stop bolt had backed out far enough that it was no longer contacting the lower end of the flight control stick at the limit of travel; instead the flight control stick was contacting the inner wall of the torque tube assembly with the control stick in the full forward position. While not considered a factor in the accident, the tube wall on the forward elevator push-rod assembly, part number 510-058, was worn at both ends, due to overtravel of the push-rod assembly within the torque tube (See Photos 3 and 4).

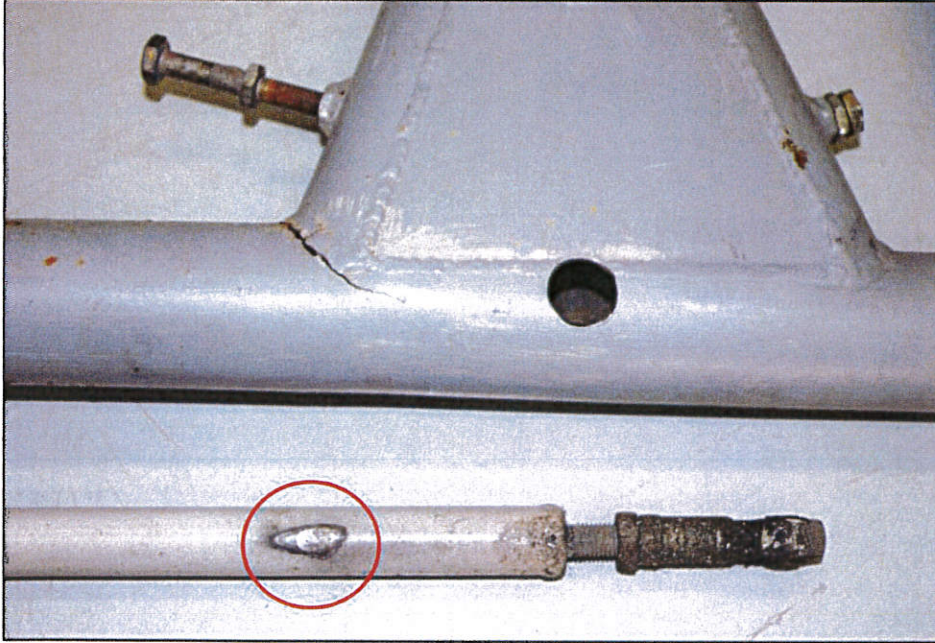
Photo 3. Wear on forward elevator push-rod (note: crack in torque tube impact related)

The wear was not visible without removing the forward elevator push-rod assembly from the torque tube. Pre-occurrence rigging of the elevator flight control system could not be determined due to the extent of impact damage; however, it is probable that the backing out of the down elevator stop bolt would have resulted in overtravel of down elevator.

Overtravel of the elevator flight control system on a Pitts S-1S due to incorrect adjustment of or backing off of the elevator stop bolts may result in interference between the elevator torque tube and the forward elevator push-rod, as evidenced by localized wear on the outer surface of the elevator push-rod. This condition increases the risk of failure of the elevator flight control system, which could contribute to an inflight loss of control.

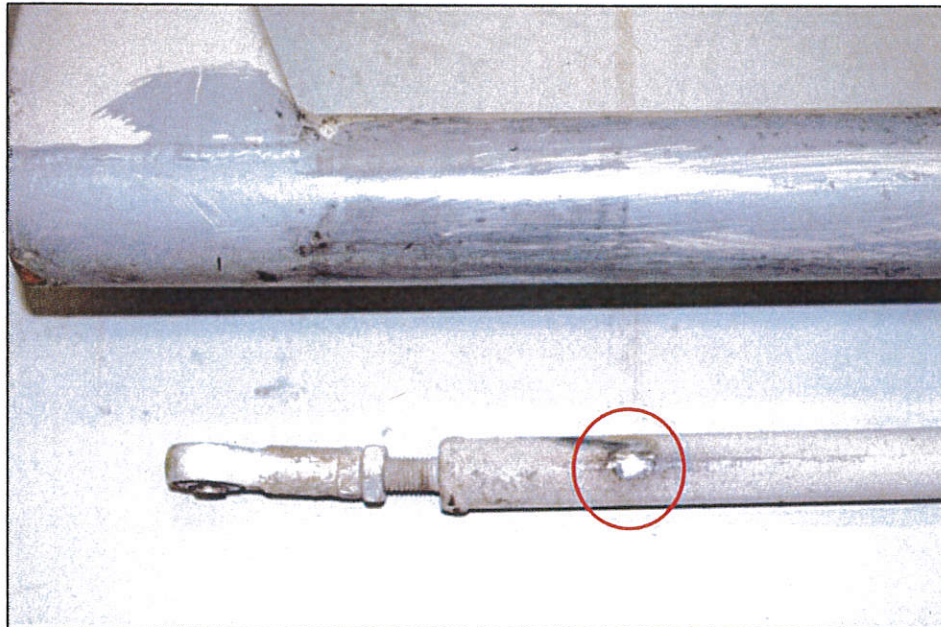
Photo 4. Wear on aft end of forward elevator push-rod
